**Flood Control Project Maintenance  
Levee Inspections**

**Fall 2012 Levee Maintenance Deficiency Summary Report**

**Reclamation District No. 2089 Stark**

**Levee Inspection Report By Mile - Fall 2012**

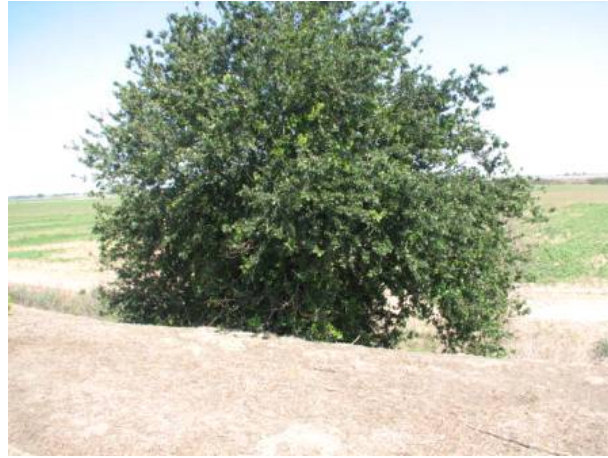
Levee Mile Report Line	9
Start Levee Mile	0.10
End Levee Mile	0.10
Location	Land Side
Category	Earthen Levee
Item	Trim / Thin Trees
05/24/2011 Issue remains unchanged since noted in the Fall 2010 inspection.	
mkhashch_f_20120927_277.jpg

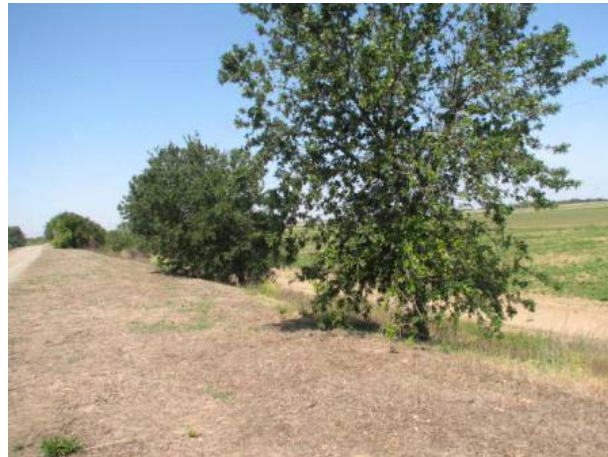
Levee Mile Report Line	10
Start Levee Mile	0.18
End Levee Mile	0.18
Location	Land Side
Category	Earthen Levee
Item	Trim / Thin Trees
05/24/2011 Both trees shown need to be trimmed up 5' to allow visibility of landside slope.	
mkhashch_f_20120927_214.jpg

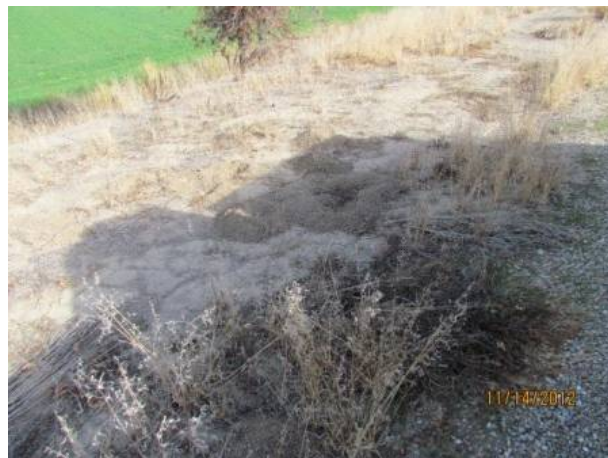
Levee Mile Report Line	11
Start Levee Mile	0.18
End Levee Mile	0.18
Location	Land Side
Category	Earthen Levee
Item	Animal Control
View of rodent activity on landside slope.	
mkhashch_f_20121119_775.JPG

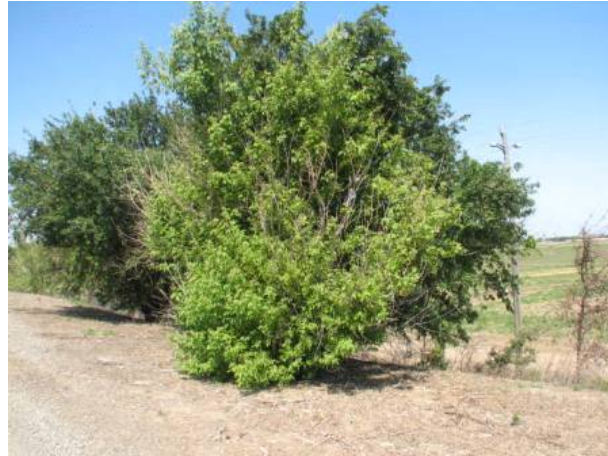
Levee Mile Report Line	12
Start Levee Mile	0.23
End Levee Mile	0.23
Location	Land Side
Category	Earthen Levee
Item	Trim / Thin Trees
05/24/2011 Tree was also noted in the Fall 20110 inspection.	
mkhashch_f_20120927_278.jpg

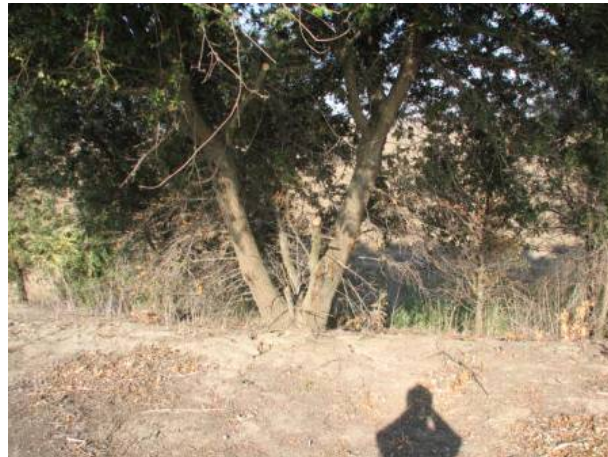
Levee Mile Report Line	12
Start Levee Mile	0.23
End Levee Mile	0.23
Location	Land Side
Category	Earthen Levee
Item	Trim / Thin Trees
11/10/2011 Tree has been limbed up, but still needs to be cleared around the bottom to permit access to the slope in the event of a flood fight.	
mkhashch_f_20120927_279.jpg

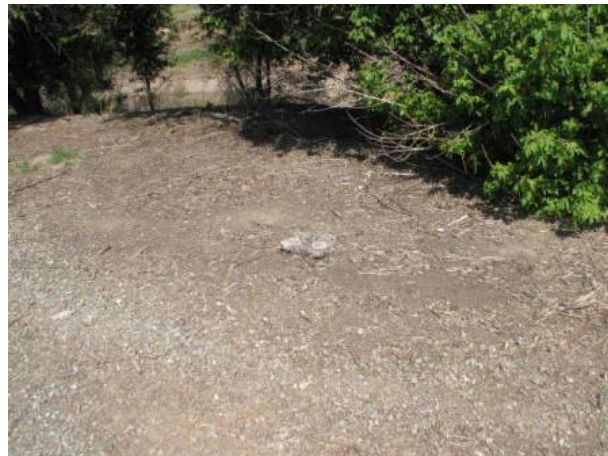
Levee Mile Report Line	13
Start Levee Mile	0.24
End Levee Mile	0.24
Location	Land Side
Category	Earthen Levee
Item	Trim / Thin Trees
05/24/2011 Stump shown in center of photo.	
mkhashch_f_20120927_222.jpg

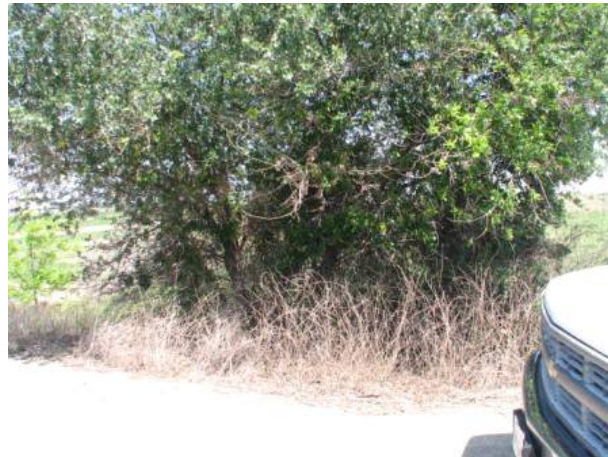
Levee Mile Report Line	22
Start Levee Mile	0.39
End Levee Mile	0.39
Location	Land Side
Category	Earthen Levee
Item	Trim / Thin Trees
05/24/2011 Tree needs to be trimmed up 5' to allow access and visibility to landside slope.	
mkhashch_f_20120927_242.jpg

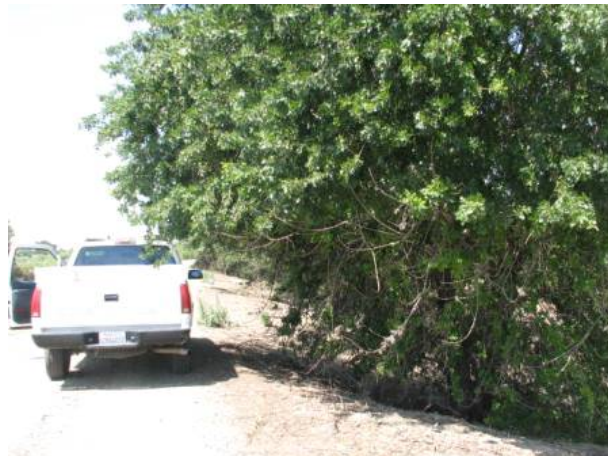
Levee Mile Report Line	23
Start Levee Mile	0.42
End Levee Mile	0.48
Location	Land Side
Category	Earthen Levee
Item	Trim / Thin Trees
05/24/2011 Trees need to be trimmed to 12' over roadway and up 5' on levee slope to allow access and visibility.	
mkhashch_f_20120927_243.jpg

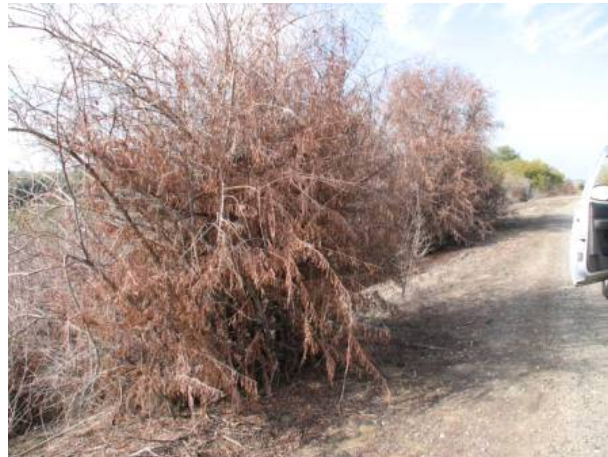
Levee Mile Report Line	27
Start Levee Mile	0.50
End Levee Mile	0.50
Location	Water Side
Category	Earthen Levee
Item	Trim / Thin Trees
11/10/2011 Woody vegetation needs to be cleared off of the upper 20' of the waterside slope.	
mkhashch_f_20120927_246.jpg

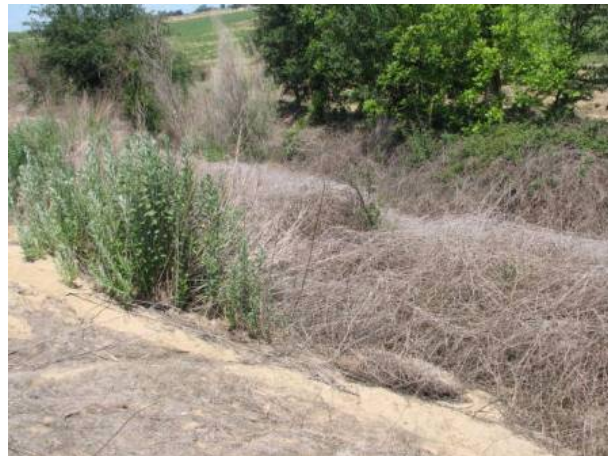
Levee Mile Report Line	28
Start Levee Mile	0.50
End Levee Mile	0.50
Location	Land Side
Category	Earthen Levee
Item	Vegetation
05/24/2011 Dead brush is too thick to allow access and visibility of landside slope and toe.	
mkhashch_f_20120927_247.jpg

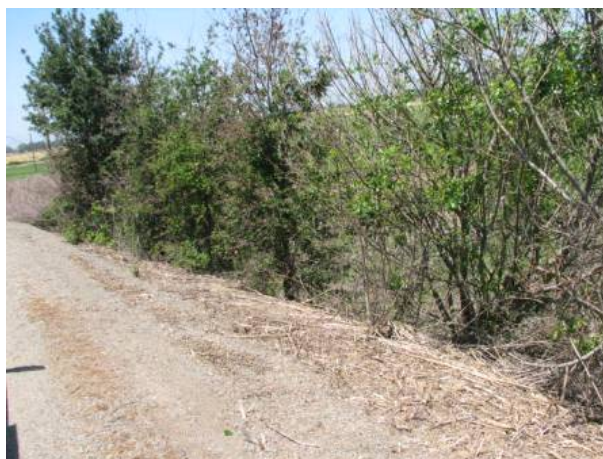
Levee Mile Report Line	30
Start Levee Mile	0.60
End Levee Mile	0.60
Location	Land Side
Category	Earthen Levee
Item	Trim / Thin Trees
05/24/2011 Issue was also noted in Fall 2010 inspection.	
mkhashch_f_20120927_285.jpg

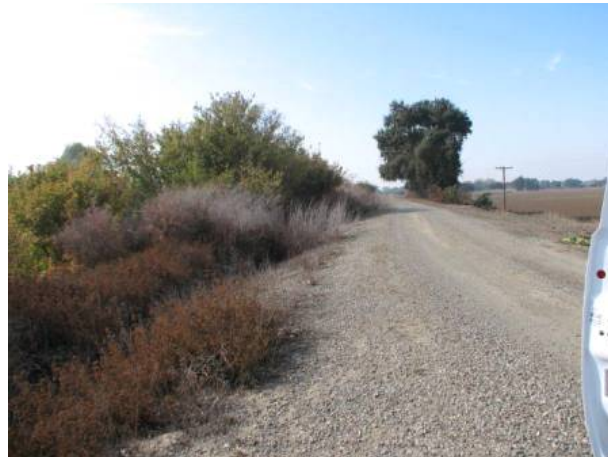
Levee Mile Report Line	43
Start Levee Mile	0.98
End Levee Mile	1.07
Location	Water Side
Category	Earthen Levee
Item	Vegetation
11/10/2011 Thick vegetation on upper 20; of waterside slope.	
mkhashch_f_20120927_251.jpg

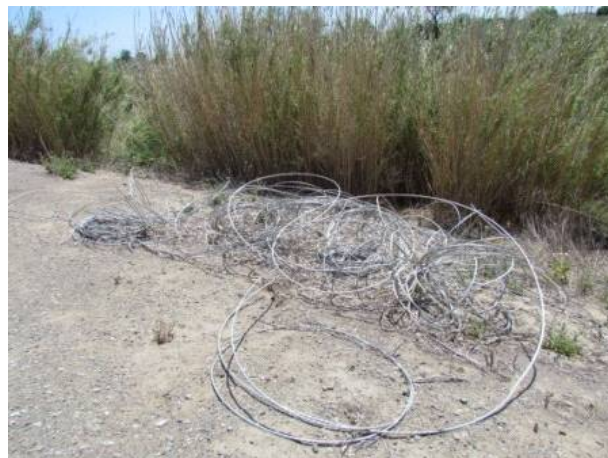
Levee Mile Report Line	44
Start Levee Mile	0.98
End Levee Mile	0.98
Location	Water Side
Category	Earthen Levee
Item	Encroachments
View of powerline wire on waterside slope. 05/24/2012	
mkhashch_f_20120927_276.jpg

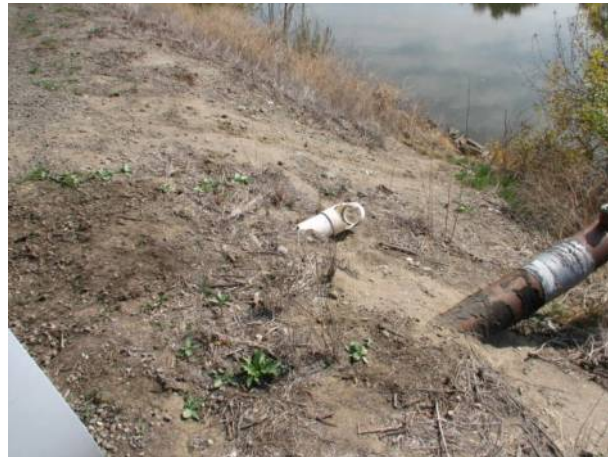
Levee Mile Report Line	56
Start Levee Mile	1.45
End Levee Mile	1.45
Location	Crown
Category	Earthen Levee
Item	Encroachments
11/10/2011 Broken PVC pipe on waterside.	
mkhashch_f_20120927_262.jpg

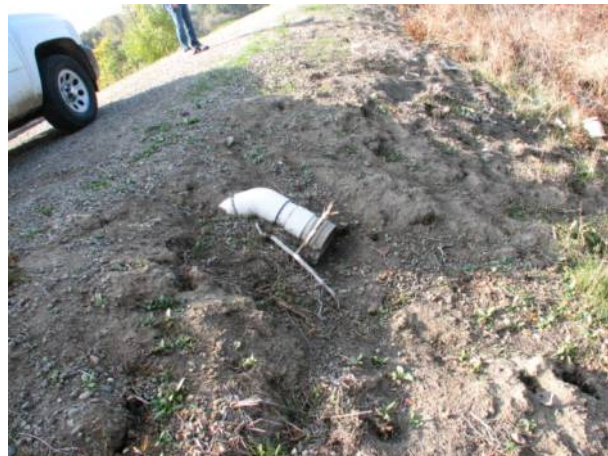
Levee Mile Report Line	56
Start Levee Mile	1.45
End Levee Mile	1.45
Location	Crown
Category	Earthen Levee
Item	Encroachments
11/10/2011 PVC pipe on landside slope. Pipe needs to be removed.	
mkhashch_f_20120927_263.jpg

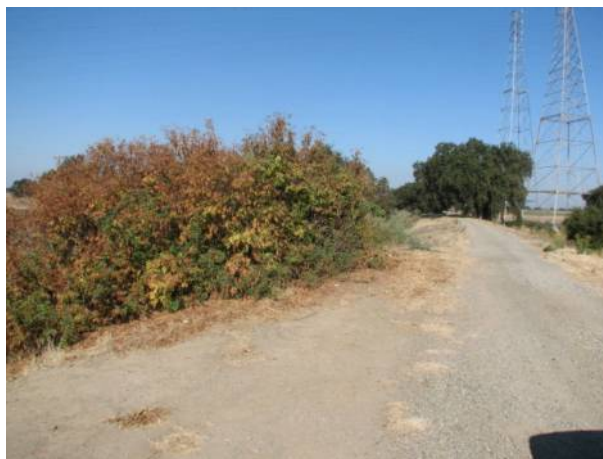
Levee Mile Report Line	3
Start Levee Mile	0.08
End Levee Mile	0.08
Location	Water Side
Category	Earthen Levee
Item	Vegetation

05/24/2011 Updated photo of issue noted in Fall 2010 inspection.

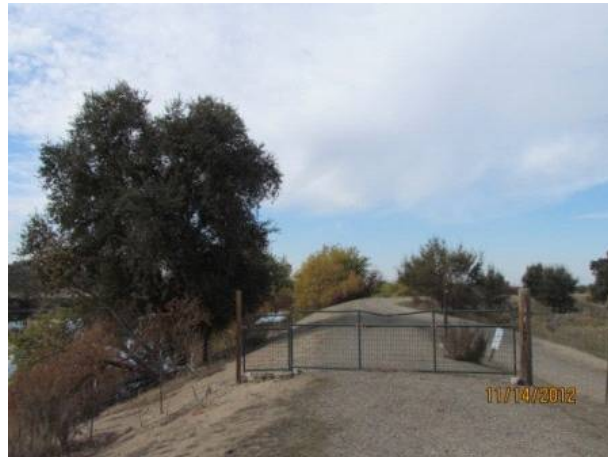
Levee Mile Report Line	5
Start Levee Mile	0.37
End Levee Mile	0.37
Location	Crown
Category	Earthen Levee
Item	Encroachments
View of gate across levee crown.	
mkhashch_f_20121119_779.JPG

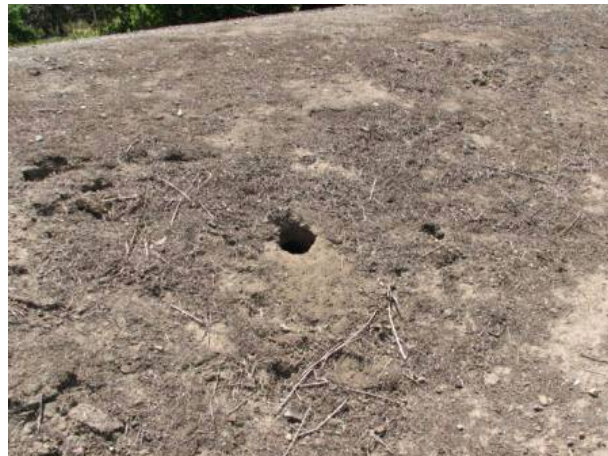
Levee Mile Report Line	6
Start Levee Mile	0.38
End Levee Mile	0.38
Location	Land Side
Category	Earthen Levee
Item	Animal Control
05/24/2011 Active rodent burrow.	
mkhashch_f_20120927_303.jpg

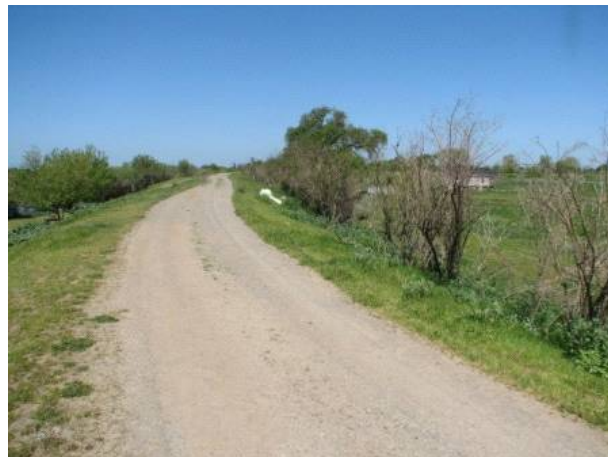
Levee Mile Report Line	7
Start Levee Mile	0.40
End Levee Mile	0.66
Location	Land Side
Category	Earthen Levee
Item	Vegetation
Brush on landside slope limits access.	
mkhashch_f_20120927_294.jpg

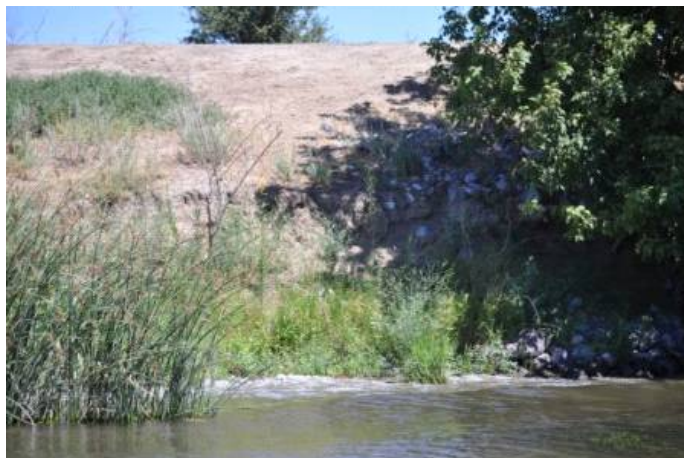
Levee Mile Report Line	8
Start Levee Mile	0.42
End Levee Mile	0.43
Location	Water Side
Category	Supplemental
Item	DWR Erosion Survey
Close view of the site	
SJR2012_RD2089U02RM28.35_1.jpg
